**3M** ESPE

Making Better Impressions

*Trouble*

*Shooting*  
*Guide*

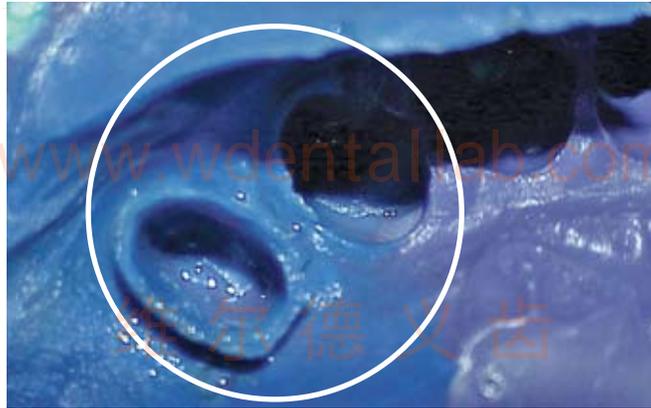
**Inhibited Setting**

**Visual Appearance:** Impression not completely set. Shiny, no detail of site.

**Result:** Inadequate surface detail on stone cast, poor fitting restorations.

Sulfur inhibition due to contact of latex gloves with tissue/tooth/retraction material or impression material.

Residues from custom temporary or provisional cements (acrylics) present.

Wear gloves proven not to contain traces of sulfur.

If contamination is suspected, scrub affected area with diluted hydrogen peroxide.

Do not use impressions already used to fabricate the temporary restoration.

Fabricate the temporary crown or bridge after final impression has been made.

Remove air-inhibited layer on the exposed surface with an alcohol wipe before making final impression.

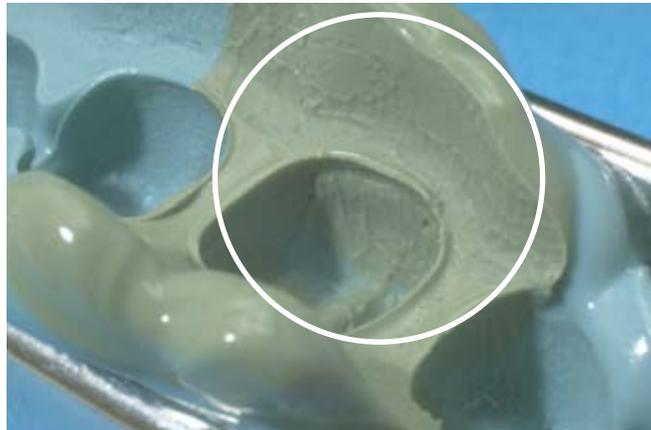
**Surface Inhibition**

Substances with pH < 4 inhibit setting reaction, most commonly by the contact with acidic retraction materials and hemostatic agents containing epinephrine or ferric sulfates.

Expired impression material does not set properly, elastomeric properties are insufficient.

Use retraction materials having pH  $\geq 4$ .

Select retraction materials and hemostatic agents not containing these chemicals.

Rinse, remove, dilute hemostatic solution with water spray and suction. Dry before taking the impression.

Check expiration date of impression material.

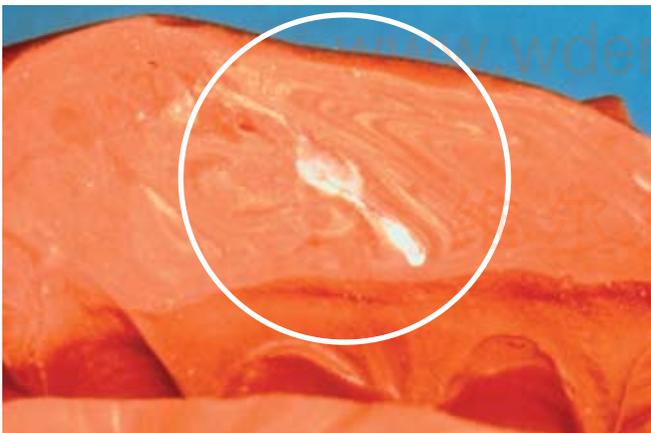
**Inadequate Mix**

Inadequate mix.

Bleed before applying mix tip to ensure even dispensing.

Use mix tip according to manufacturer's instruction for use.

Ensure mix tip is correctly attached.

When using hand-mix materials ensure correct mixing ratio and thorough mix of catalyst and base paste.

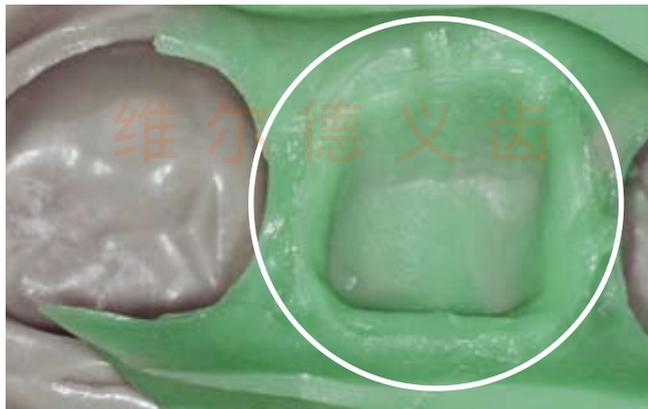
**Lack of Impression Detail**

**Visual Appearance:** Muted detail reproduction.

**Result:** Crowns may be too tight, or loose, and not fit correctly.

CAUSE	SOLUTION
Impression material stored at elevated temperature.	Store impression material at room temperature.
Impression material stored at too low a temperature (prolongs the setting reactions, changes viscosity and requires exceptionally high extrusion forces for automix materials).	Keep impression material at a temperature of 18°C/64°F at least one day prior use.
Thick blood/saliva pooled around prep.	Remove blood and saliva prior to making impression.  Use 2-step impression technique.
Inadequate retraction of sulcus around prep.	Use good retraction technique, with proper moisture control.
Exceeding the working time.	Follow manufacturer's working time specifications.  Choose material with longer working time.
Inadequate disinfection effects surface quality (detail reproduction) and dimensional stability.	Use water based disinfectants according to FDA guidelines.  Follow manufacturer's instructions for use.

Substances with  $\text{pH} < 4$  inhibit setting reaction, most commonly by contact with acidic retraction materials and hemostatic agents containing epinephrine or ferric sulfates.

Incorrect storage conditions of the final impression affects surface quality (detail reproduction) and dimensional stability.

Use retraction materials having  $\text{pH} \geq 4$ .

Select retraction materials and hemostatic agents not containing these chemicals.

Rinse, remove, and dilute hemostatic solution from the preparation with water spray and suction. Dry before taking the impression.

Rinse polyether impressions with water and blow dry before sending it to the lab.

Do not send the impression in the same bag as an alginate impression to the lab.

Avoid storing impressions in sealed bags.

Store the impression at room temperature away from direct sunlight.

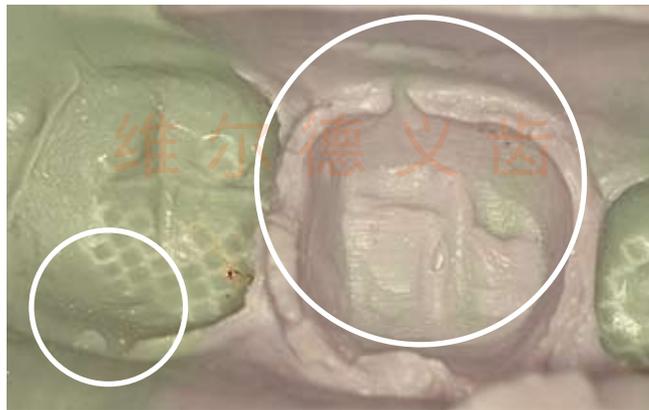
**Void Caused by Syringe Technique**

**Visual Appearance:** Voids/holes on margin of the prepared teeth. Incomplete margin.

**Result:** The fit and function of the final restoration may be compromised. Short crown margins and/or open margins.

CAUSE	SOLUTION
Air trapped in intraoral syringe.	Properly bleed filled elastomer syringe.  Keep tip immersed in material when loading syringe.  Do not stop when in the middle of loading syringe.
Air trapped while filling impression tray.	Keep mix tip immersed in tray material while filling the tray.
Improper syringe technique.	Keep syringe tip immersed in wash material to avoid entrapping air.  Wiggle and stir while syringing. Push material forward.
Inadequate coverage of marginal area with light body impression material.	Use wash material liberally on preparation and abutments.

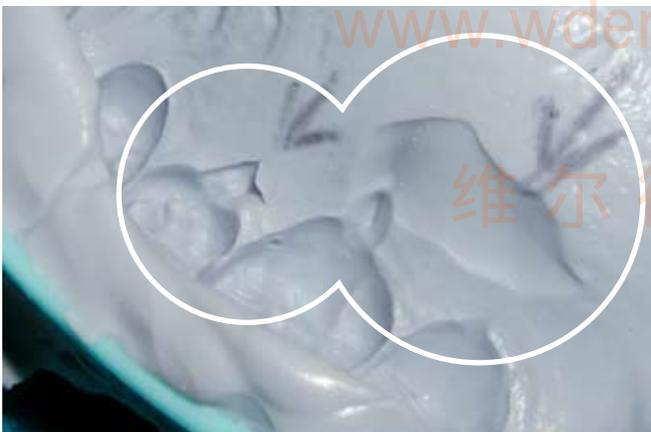
Trapped Air or Moisture

Blood and saliva contamination around prep.

Use good moisture control technique. Rinse and dry prep area before taking the impression.

Stop bleeding by using appropriate retraction technique and hemostatic agent. Leave cord in sulcus until no blood or saliva are present before syringing the light body impression material. Consider two-cord retraction to displace tissue and control fluids.

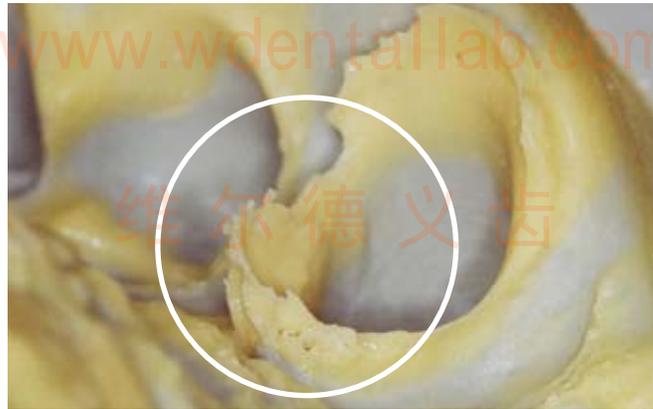
**Poor Retraction — Insufficient Tear Resistance**

**Visual Appearance:** Rip, or visible tearing on the margin of the preparation.

**Result:** Short crown margins and/or open margins.

CAUSE	SOLUTION
Expired impression material.	Check expiration date of impression material.
Inadequate mix.	Bleed before applying mix tip to ensure even dispensing.  Use proper mix tip.  Ensure mixing instructions are followed and materials have a streak-free appearance.
Insufficient retraction.	Displace tissue to allow the impression material to access prepared area.  Consider two-cord retraction. Leave pilot cord in the sulcus when taking the impression.  Use impression material with sufficient tear resistance.

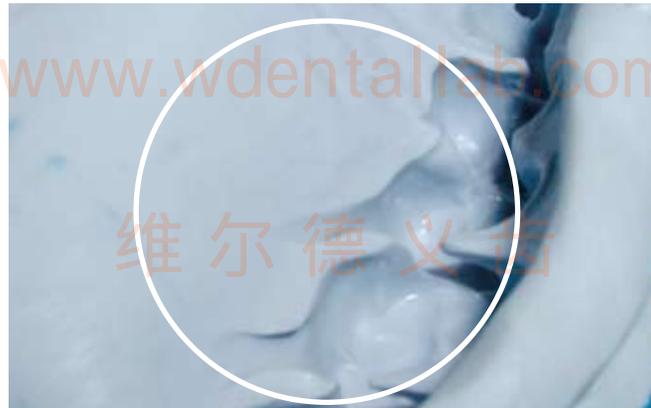
**Lingual Pulls**

**Visual Appearance:** V-shaped void, trough-like.

**Result:** Failure to capture complete and accurate dentition.

CAUSE	SOLUTION
Exceeding the working time.	Follow manufacturer's working time specifications.  Choose material with longer working time.
Tray movement or repositioning after seating.	Do not move tray after seating.
Insufficient amount of impression material used.	Use more material to create back flow effect.
Impression tray does not support flow of impression material.	Use lingual stops.  Use an impression tray that supports the flow of the material.

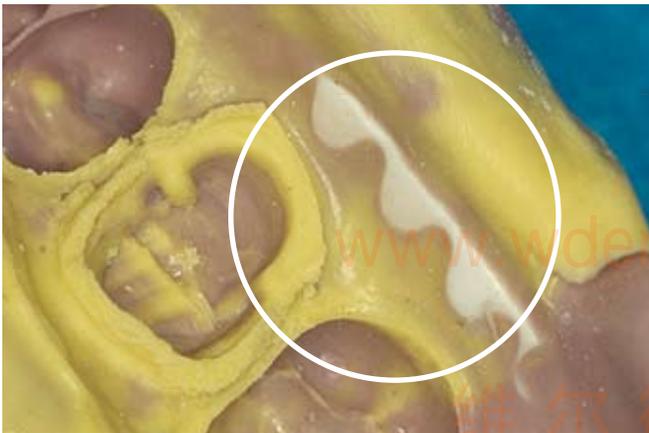
Contact with Impression Tray

**Visual Appearance:** Show-through of tray. Impression tray exposed.

**Result:** Restoration may have slight distortion at marginal area, or rocks.

CAUSE	SOLUTION
Prepared teeth contact the sides or bottom of impression tray.	Use proper size tray. Test various tray sizes to ensure proper size.
Tooth contact with the pre-set tray material when using the two-step technique.	Carve out tray material properly before applying wash.
Insufficient impression material used.	Fill tray adequately.

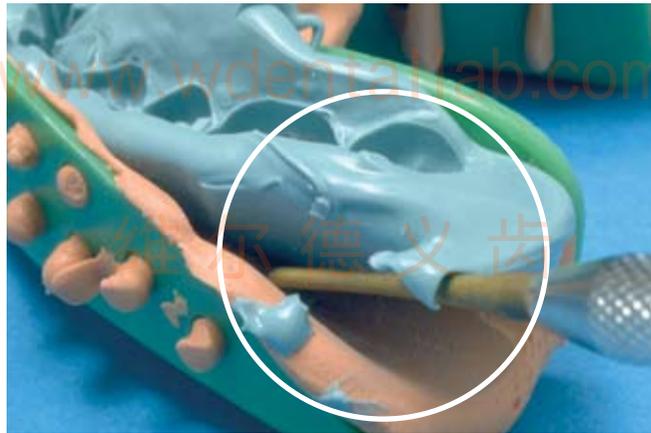
**Poor Bond Between Heavy Body and Light Body Material**

**Visual Appearance:** Heavy body and light body materials not blended, or mixed together.

**Result:** Restoration will not seat or fit properly.

CAUSE	SOLUTION
Exceeding the working time.	Follow manufacturer's working time specifications. Choose material with longer working time.
Impression material stored at elevated temperature.	Store impression material at room temperature.

VPS	SOLUTION
Sulfur or acrylic contamination of pre-set heavy body material in two-step technique.	Avoid contact with sulfur contaminants: Wear gloves proven not to contain traces of sulfur.  Avoid contact with acrylic and methacrylic contaminants: Ensure impression material does not come into contact with methacrylate residue from acrylate temporary materials.

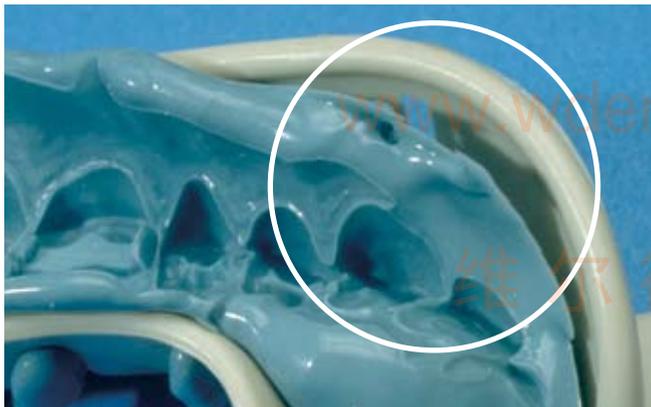
**Separation of Material from Tray**

**Visual Appearance:** Impression pulling away from the sides/bottom of tray.

**Result:** Crown(s) may be tight and not seat fully, or require excessive internal adjustment.

CAUSE	SOLUTION
No tray adhesive used.	Use tray adhesive.
Incompatible tray adhesive used.	Use appropriate tray adhesive. VPS adhesive for VPS. Polyether adhesive for polyether materials.
Inadequate drying time for tray adhesive.	Follow manufacturer's instructions for application, and drying time.
Thin plastic trays allow deflection, which can cause rebound upon removal.	Use a tray that fits better, and is stiffer and more rigid.

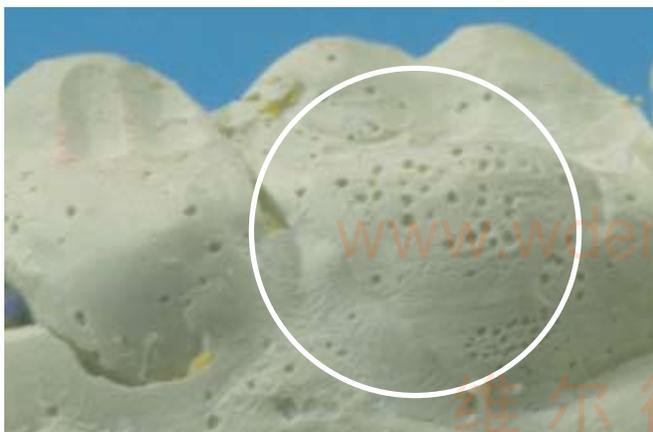
Stone Model with Hydrogen Evolution Voids

**Visual Appearance:** Voids on margin, powdery cusp tips on incisal edges on prepared tooth. “Golf-ball” appearance of stone model.

**Result:** Incomplete seating of indirect restorations.

CAUSE	SOLUTION
Tooth contact with impression tray, or gauze of double bite tray causes water to leach out of the tray, dehydrating the stone.	Instruct patient to bite passively in centric occlusion when using dual arch trays.  Fill tray with sufficient amount of material.
Cast not made according to model preparation guidelines and lacks detail.	Provide as much information as possible to the lab. Indicate type of impression material (polyether or VPS) and whether or not the impression has been disinfected.
<b>VPS</b> Hydrogen gas emission.	Follow manufacturer’s instruction for casting time.
